MANUAL of *River Restoration* TECHNIQUES

UTILISING SPOIL EXCAVATED FROM RIVERS

RESTORING MEANDERS TO STRAIGHTENED RIVERS

ENHANCING REDUNDANT RIVER CHANNELS

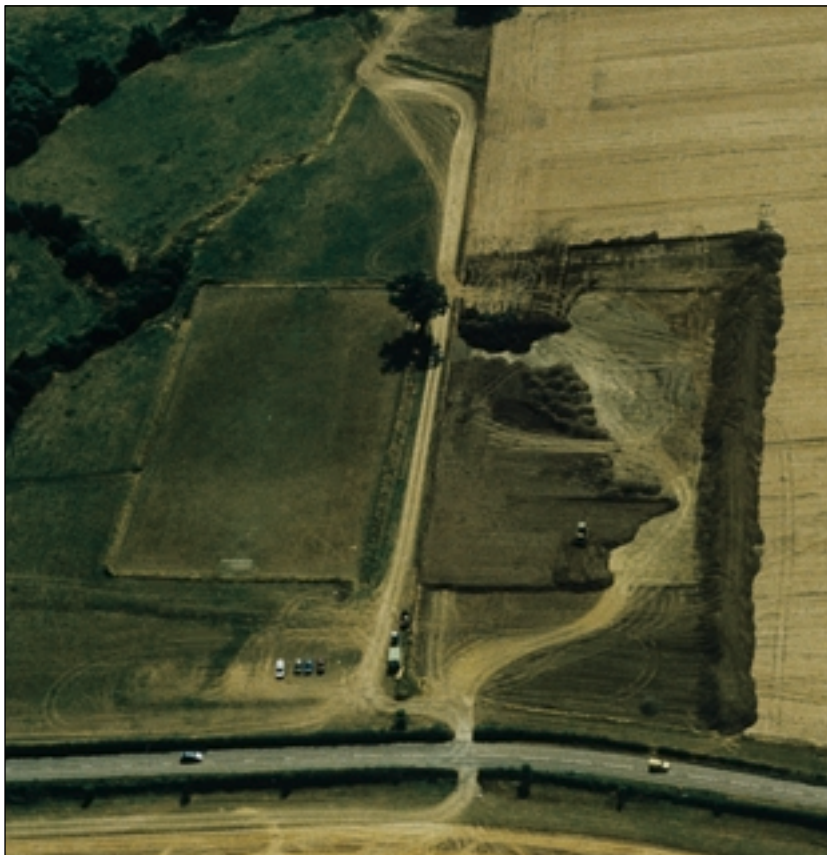
Construction of landform
in arable field to right of
football pitch – 1995
Photo: Environment Agency

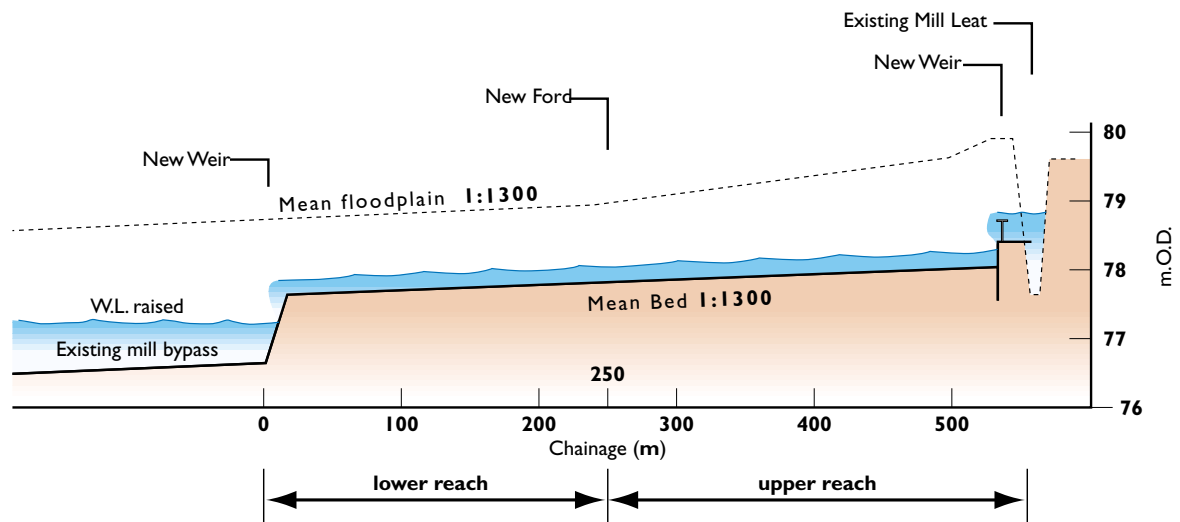
Figure 1.1.2

LONGITUDINAL PROFILE

possible whilst having just sufficient depth to contain summer spates. The resultant channel bed is elevated higher than the old mill by-pass, but is lower than the retained water level in the mill leat which feeds it. Drop weirs were therefore required at each end (see 5.1 and 5.2).

Whilst weirs are generally undesirable, the alternative of deeper channels was more so at this site. The drop at the downstream end was reduced in height as a consequence of introducing new meanders downstream of the mill; these raised normal water level in the existing mill by-pass to historic levels (see 1.2).

Longitudinal profile (fig. 1.1.2)

(fig. 1.1.2). The upper banks were graded back as flat as practical.

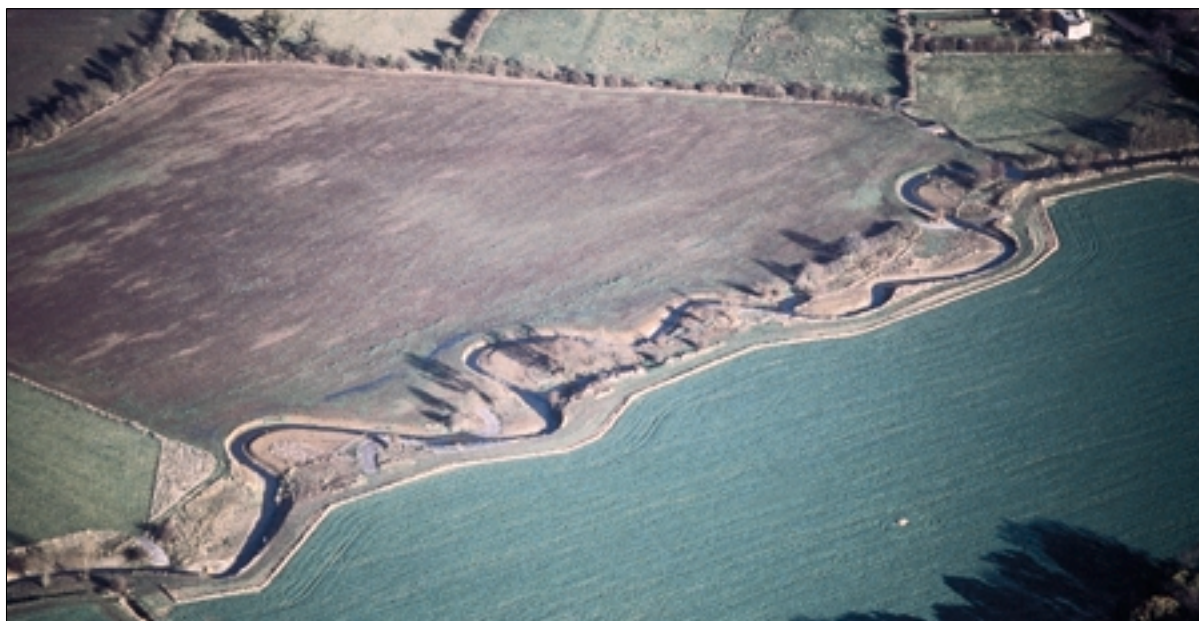
Aerial view of new meanders – July 1996

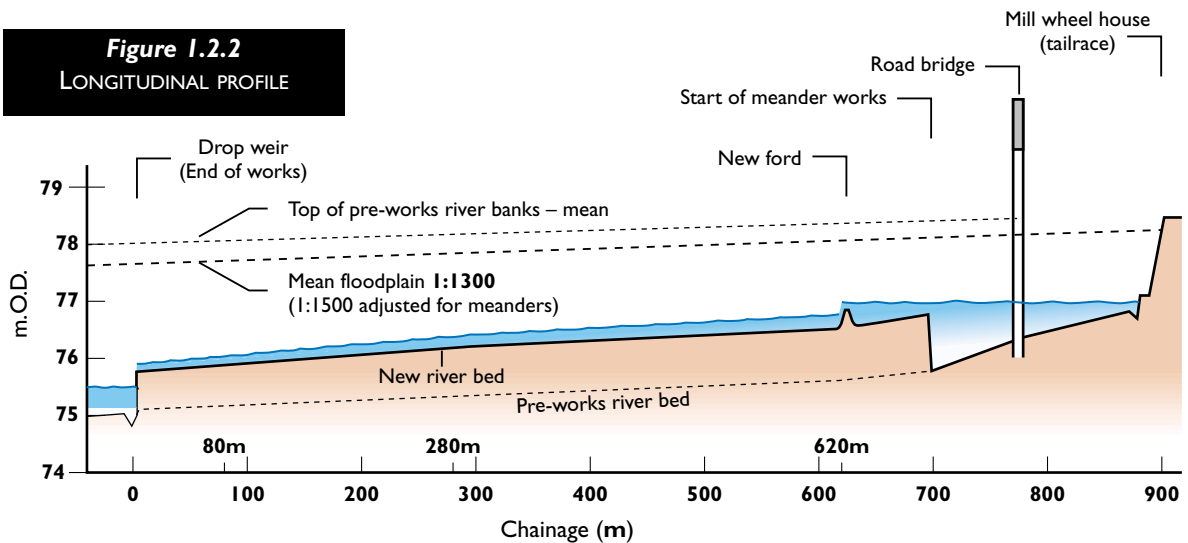
RESTORING MEANDERS TO
STRAIGHTENED RIVERS**Figure 1.2.2**
LONGITUDINAL PROFILE

The raised bed enabled impoundment of water upstream of the works, restoring historic levels in the mill pool and the mill by-pass. A stone ford was built at ch. 620m to safeguard water levels against any downward scour of the new bed.

Longitudinal profile (fig. 1.2.2)

These were all lowered by c. 0.4m to levels that approximated to the mean floodplain levels (fig. 1.2.2).

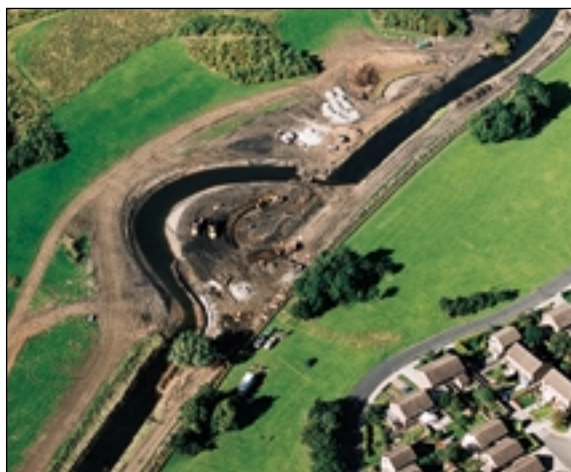
Meander excavation – Autumn 1995

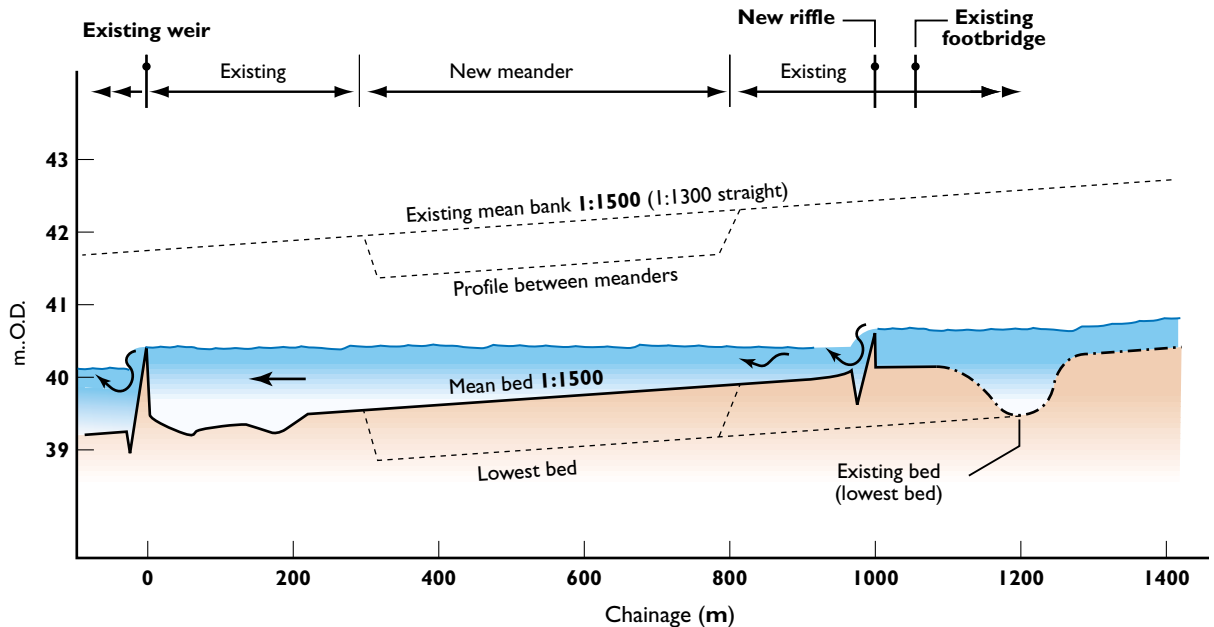
Figure 1.4.2
LONGITUDINAL PROFILE

The original mean bed gradient of 1:1300 paralleled the mean bank gradient at a depth of c. 2.4m.

The new mean bed gradient and level matches the existing but flattens to 1:1500 because of the increased length created. Bed scour around each meander was expected to reach c.1m depth as observed at an existing bend at ch. 1200m. This is shown as 'lowest bed' on the long section 1m below mean bed. Conveyance of floodwaters across the new meanders was facilitated by a general lowering of inter-meander land levels by c. 0.6m. This also enhanced water storage aspects of the 1 in 100 year flood hydrograph, attenuating the peak flow downstream.

Longitudinal profile (fig. 1.4.2)

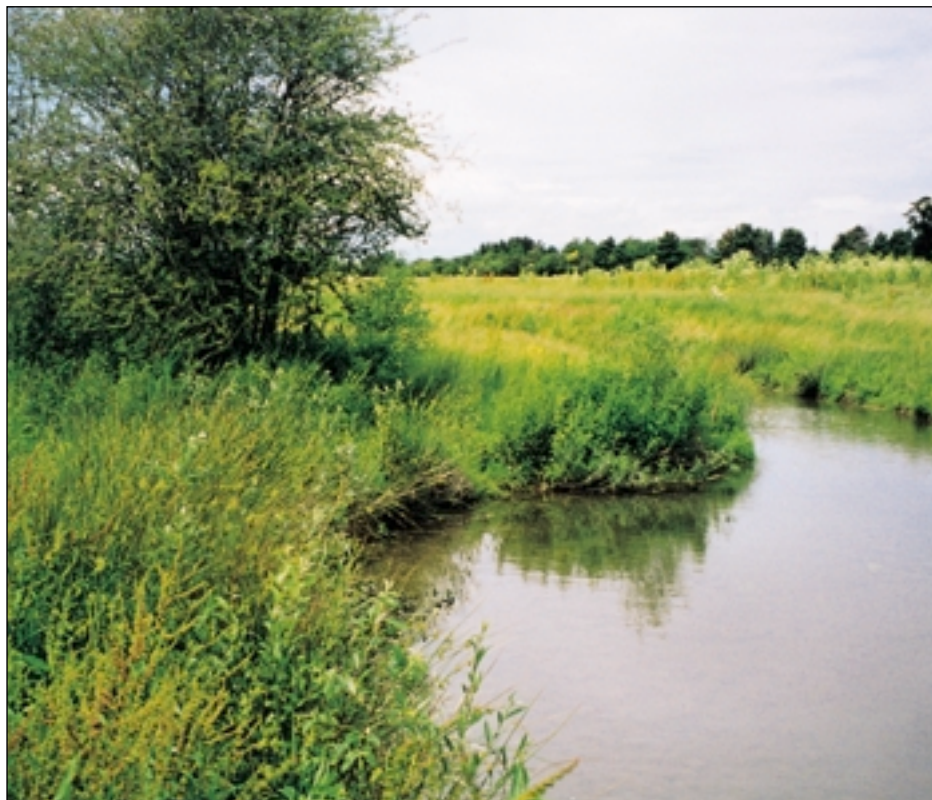
New bay at start of lower meanders (fig. 2.2.2)

The new meandering channel is smaller than the existing channel upstream and its bed is elevated c. 1m higher. As a result, water in the upstream channel is impounded and slow moving which contrasts with a marked increase in velocities within the new channel. The design of the junction of the old and new channels reflects these hydraulic conditions. The risk of downward scour of the new bed was alleviated by backfilling the existing channel bed where it abuts the new and adding a layer of stone to create a secure transition. To complete the diversion, the old channel was backfilled in a manner that created a small marshy bay within which the slower moving floodwaters approaching the new meander can eddy freely before entering it. This was preferable to complete backfilling and having torevet the fill to resist erosion.

Opposite the bay, an old drainage ditch entered the river. This was incorporated and enlarged to enable floodwaters to pass freely from the river out onto the lowest part of the floodplain, remote from the main river course. As a further safeguard against downward erosion of the new river bed, a stone ford was created 80m downstream where the new channel crosses over the line of the original (see Part 8). This ford acts like a small weir and therefore 'fixes' both bed and normal water levels upstream.

View of shallow bay X

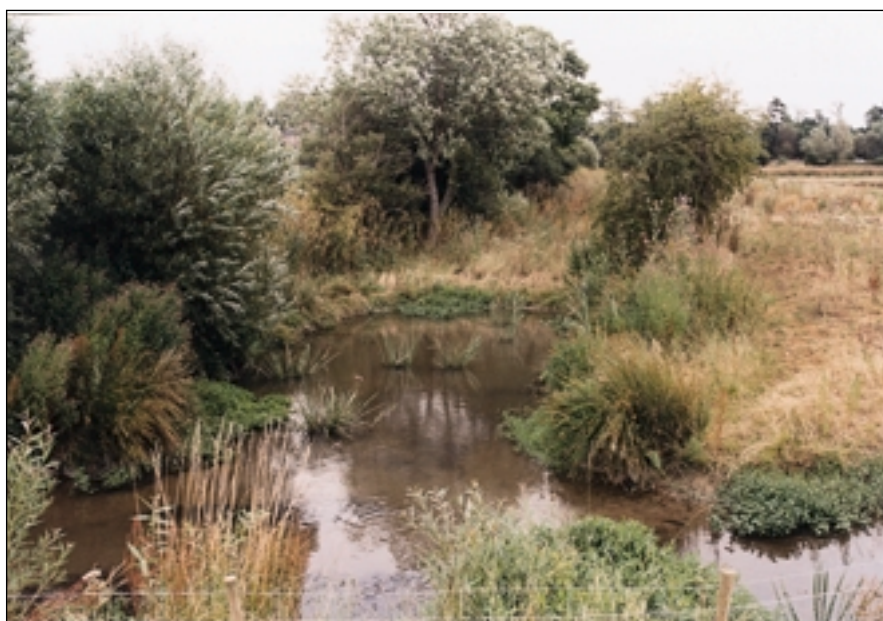
Small backwater A

Two backwaters were created where the new course crosses over the old course. One is much larger than the other, and each is different in nature.

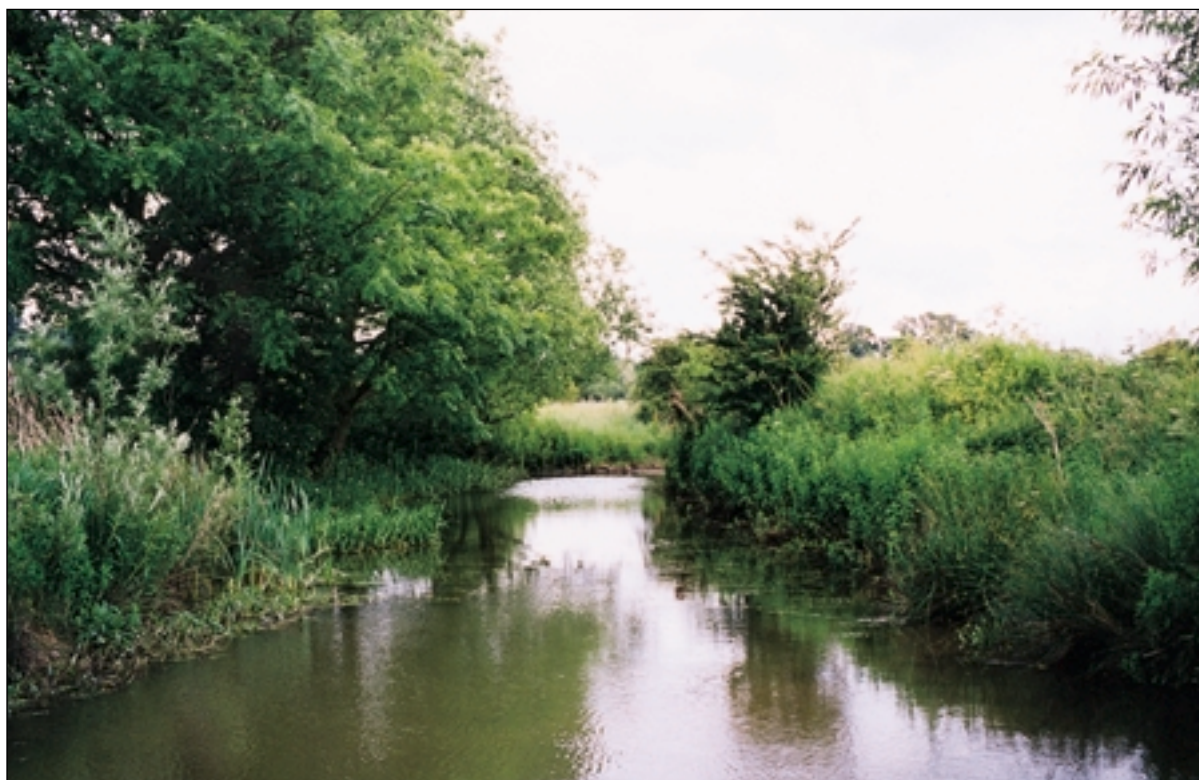
Large backwater **B**

Backwater B contrasts with A in that the retained trees along the old course all overhang open water and the new channel approaches from behind the trees rather than towards them. The hydraulics are entirely different as a result. The old river bank, behind the trees, remains at a high level preventing any floodwater from passing into the backwater save for small volumes that occasionally pass over the infilled length of channel. The backwater is thus a quiet refuge of still water, and hydraulic interaction with the river is limited to rise and fall of water levels.

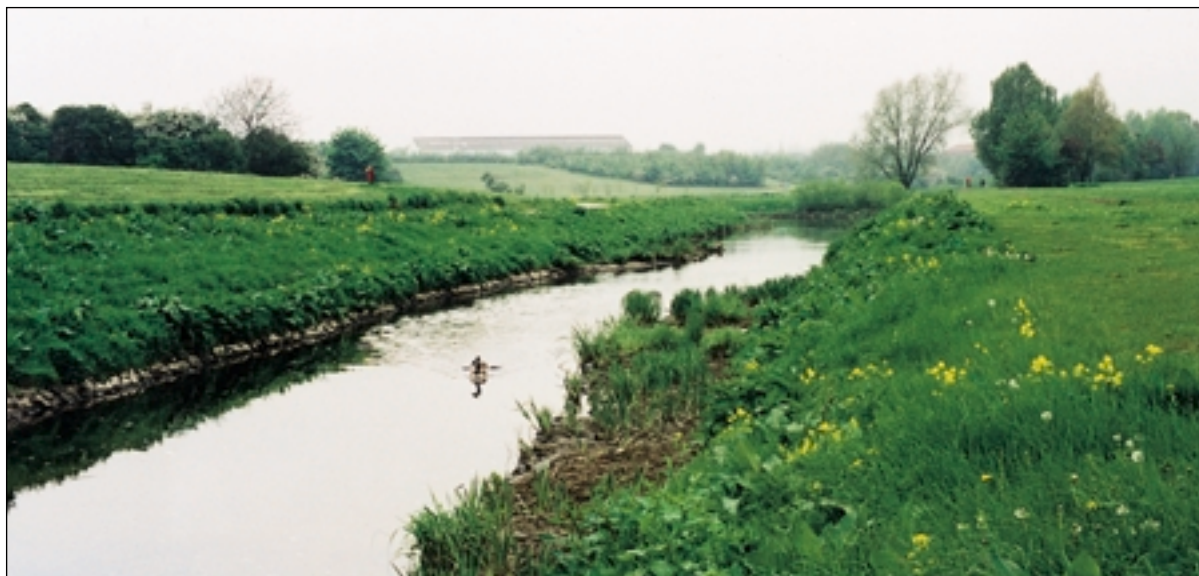
Type A Ledge on the Skerne – May 1998

Type A margins using plant pallets were installed downstream of the footbridge in the autumn of 1997 and overwintered satisfactorily in dormant conditions after several floods. Early summer 1998 growth was patchy with some silt banks smothering pallets. Growth was sufficient to ensure the spread of species to generate the dense cover required. Notable species that survived include occasional purple loosestrife and meadowsweet.

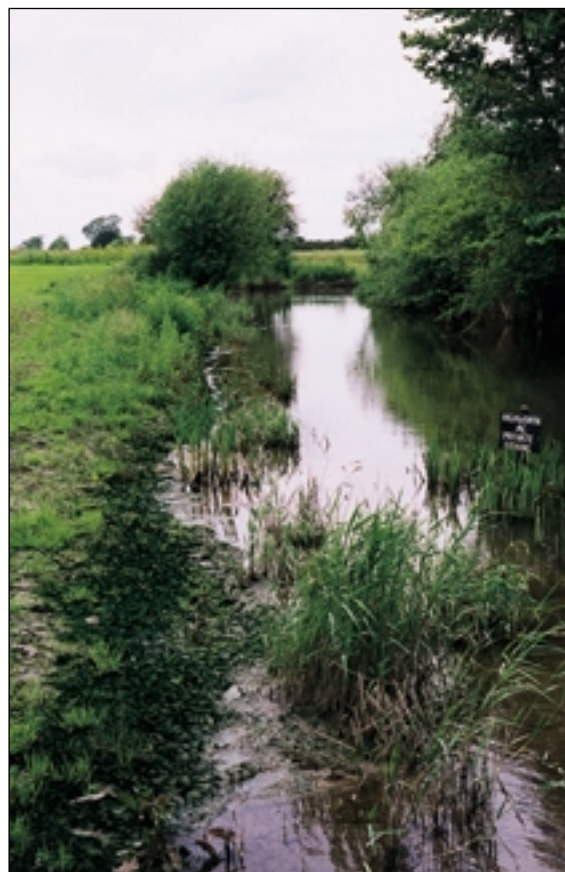
The ledges overwintered well in dormant conditions with no structural damage by floods although little more than 50% of the plants appeared to have survived to grow on during summer. The ledges are developing very well (1998) and creating both emergent vegetation habitat and landscape enhancement in the short stretch of river that previously had the least habitat and visual amenity value.

Type A and B ledges on the Cole after one winter

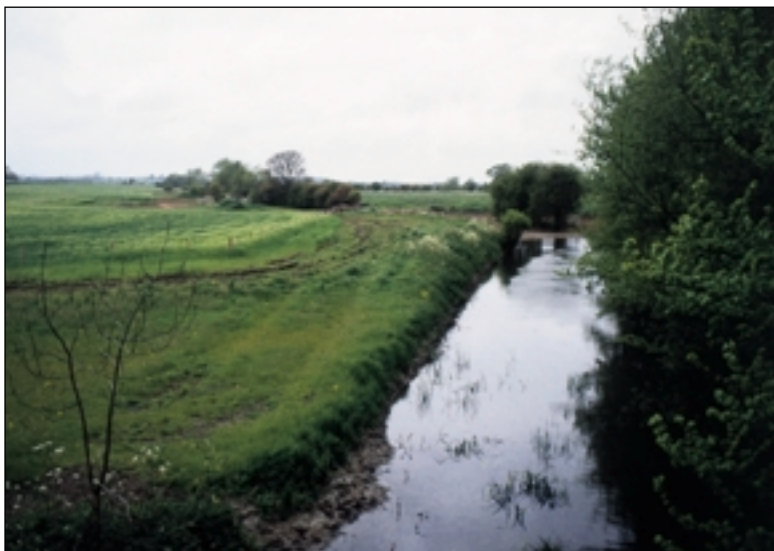
Prior to re-profiling and ledge construction – May 1996

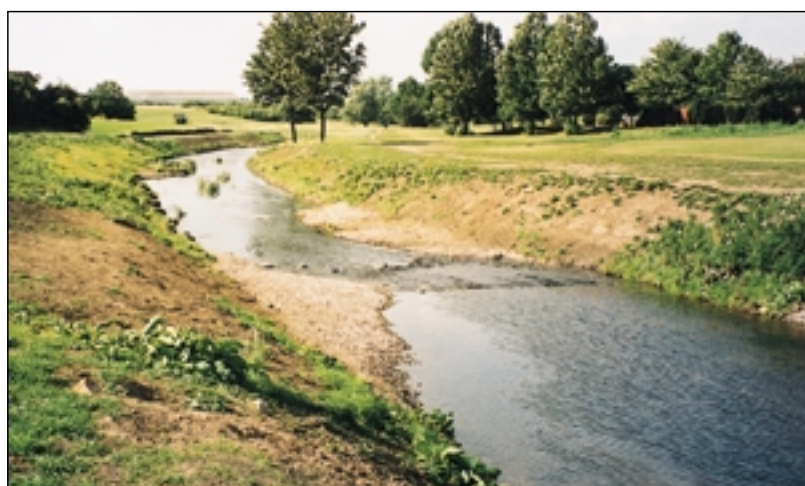
Firstly, the sight and sound of water cascading over the riffle is enjoyed by people using the footbridge. Also, the regulation of normal water levels upstream has helped in introducing stable marginal planting ledges where water birds and mammals can always be seen. Two surface water outfall pipes just upstream (one 900mm diameter) are always submerged because of the riffle (see 9.1). Children regularly paddle in the shallow flow over the riffle. In anticipation of this the design needed to be as intrinsically safe as possible.

Stone Riffle downstream of
Hutton Avenue footbridge

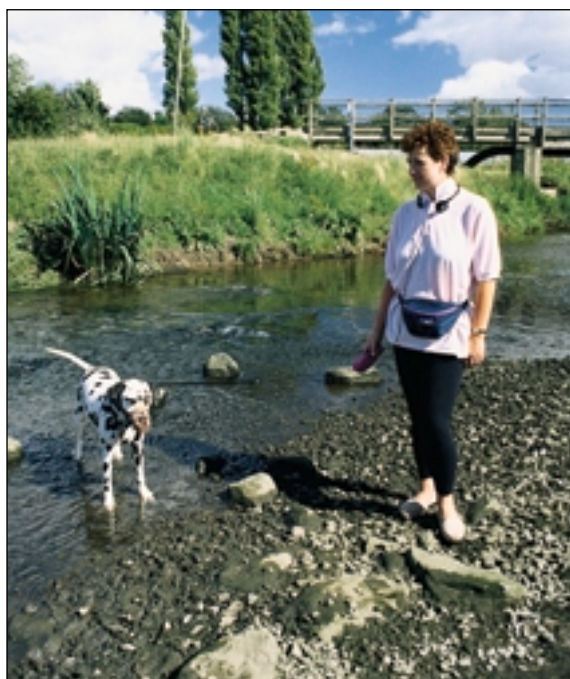
Of particular note is the popularity of this spot with children who can gain safe access to the river and paddle in the shallow water, where the bed is firm and stoney.

The riffle allows easy access
down to the river
– November 1996

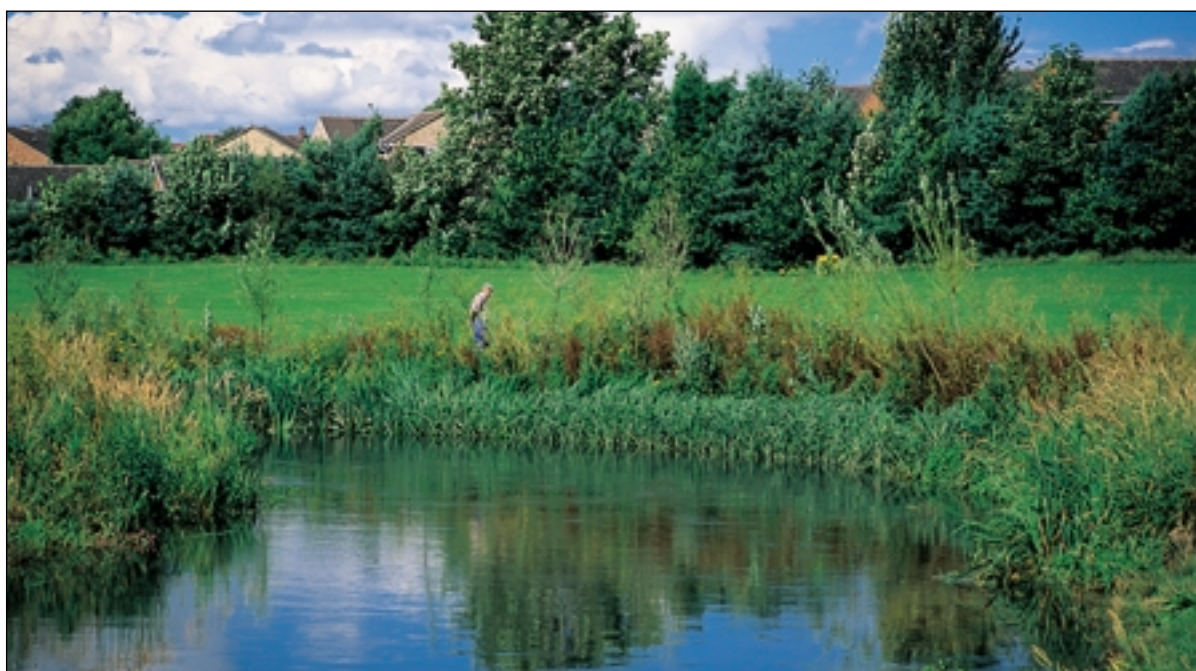
Log toe revetment three years after construction

This technique was used in two locations and both have performed well with dense willow growth up to 2m high along the bank and a thick margin of plants along the water's edge, all of which are accreting river silts in successive floods. Rooted willow plants established much more strongly than unrooted slips, but this is not uncommon with the grey/goat species selected. Other willow varieties are known to strike readily from slips. Species that are indigenous to the site are always preferable. Brushwood containing willow cut locally can be built into the lower banks as an alternative to the geotextile utilised at the Darlington site which was virtually barren of trees.

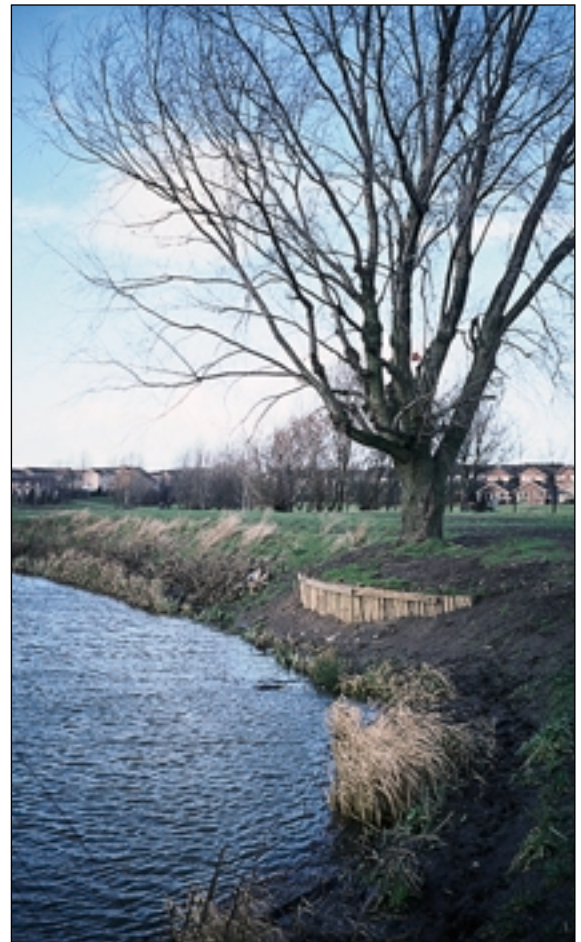
The revetment of the exposed roots has performed well, following many high flows since its construction. The roots are no longer exposed and the turf and other planting has grown to give added protection. Well used by a variety of people, the structure has become a seating area providing shade.

Protected roots after work completed – February 1997

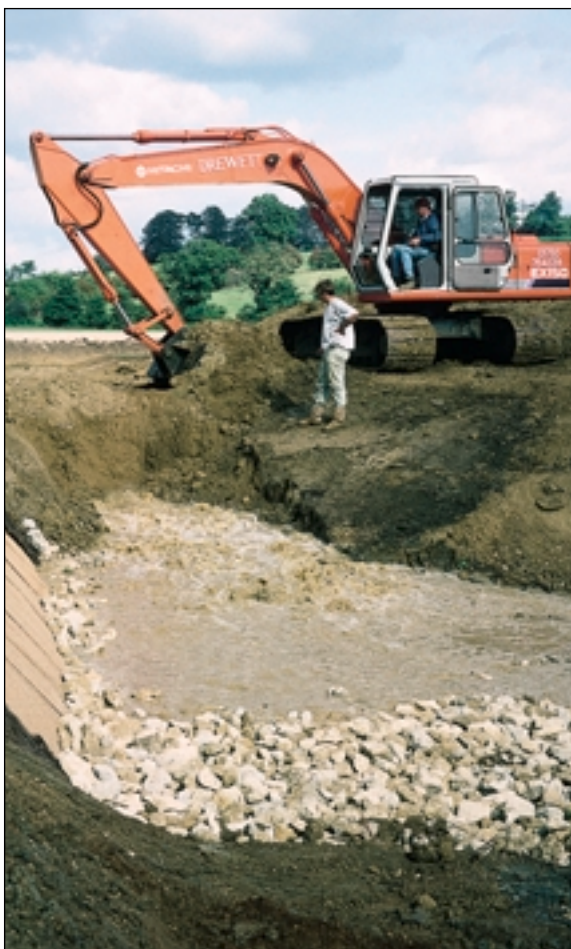
Construction of coir matting revetment
– river being released

Coir was installed on both banks at the crossing located mid way between the ford (ch. 280m) and the stock bay (ch. 100m), as well as opposite the large backwater. Hurdles were installed opposite the small backwater. A plan of the reach can be found in 1.2.

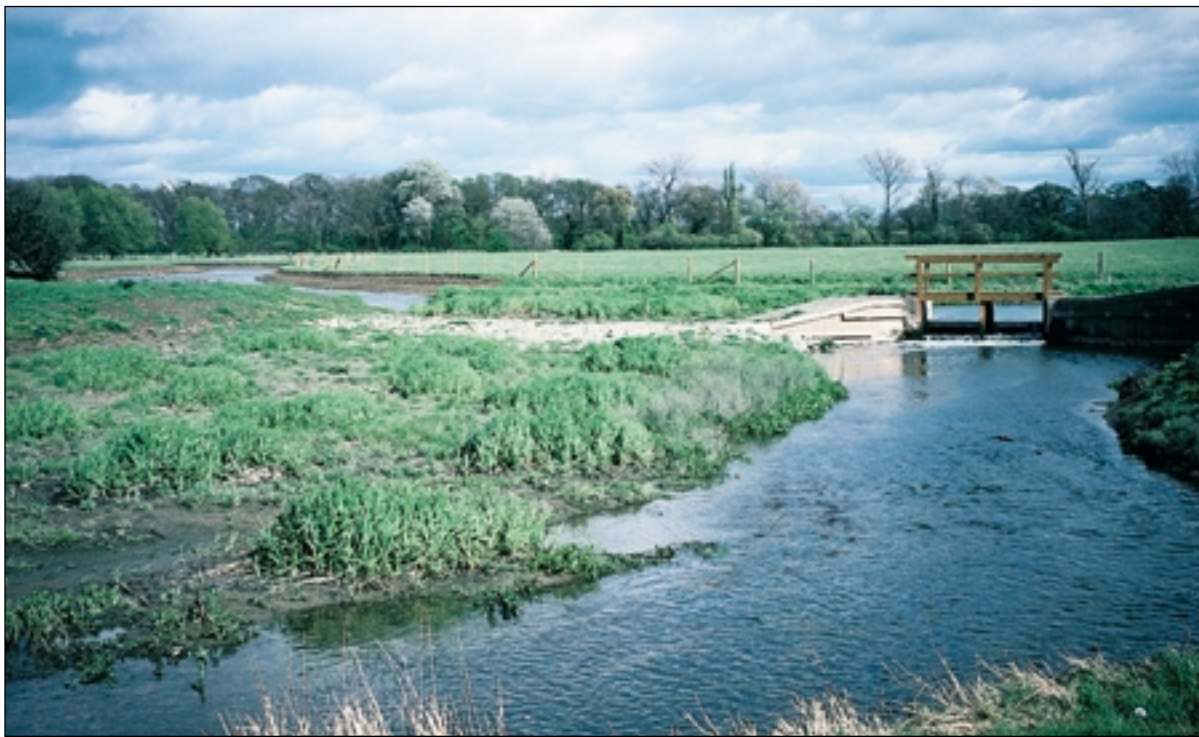
Spillway alongside bifurcation weir
– April 1997

The hydraulic capacity of the flume is small (to suit base flows) so a 10m wide spillway is incorporated alongside to feed sufficient floodwater to fill the new channel. The crest level is only 0.1m above the normal water level in the leat so it operates frequently. Below the spillway, a large area of land is gently graded out towards the new channel which sustains marshy conditions around its inner margins. This low lying area is largely flooded before overspill occurs, ensuring a fairly smooth combining of floodwaters passing downstream. Water in the new channel rises quickly, ensuring the overspill is completely submerged (drowned) at an early stage of a rising flood, thereby further reducing scour potential.

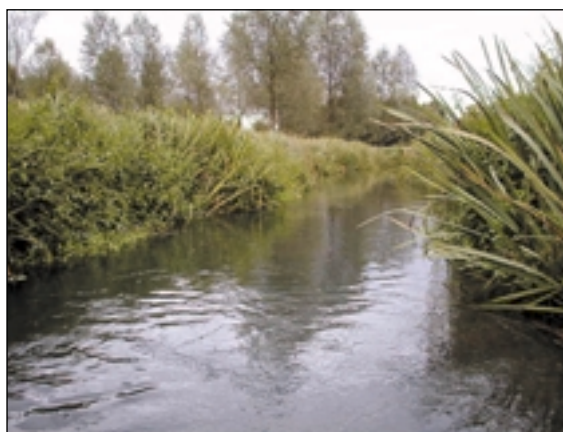
Before: sluggish deep water with encroaching sedge

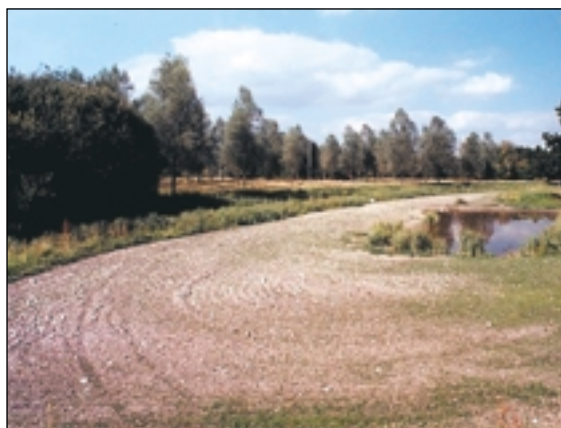
New pond with early growth, showing the gravelly nature of the floodplain material

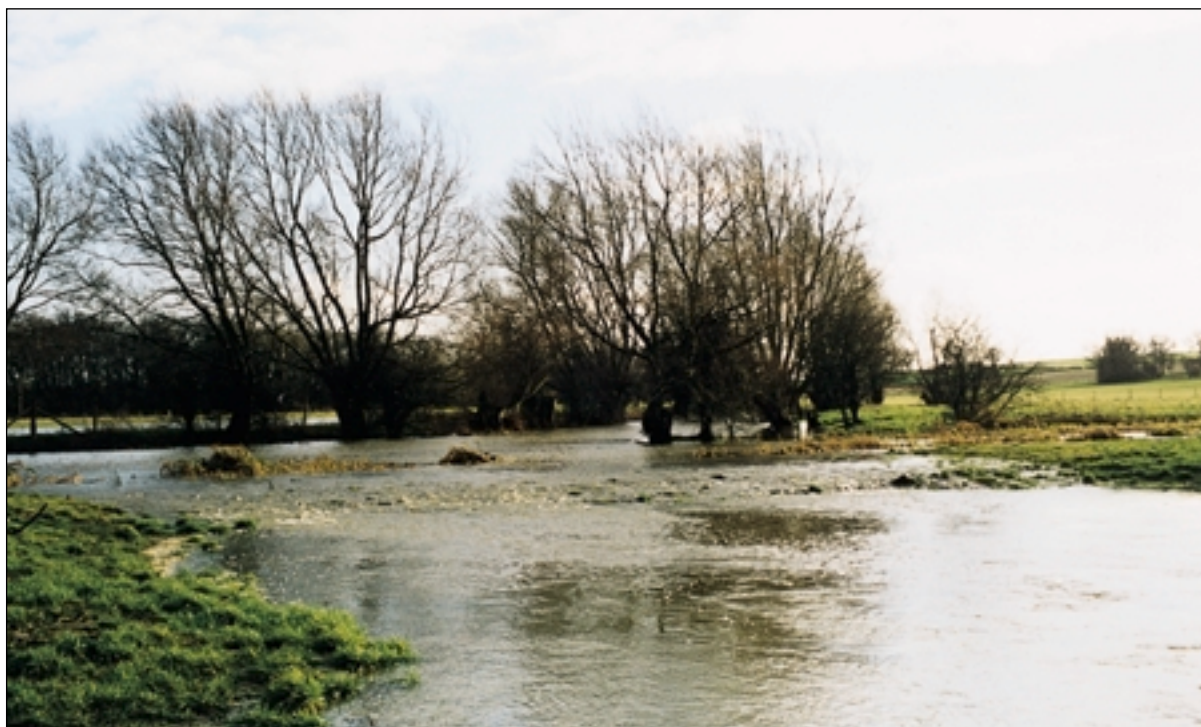
Spillway **S2** in flood

Spillway S2 begins to operate only after S1 has filled the new channel with water. Water spilling over S2 passes directly into the new channel causing it to overflow its banks and initiate field flooding. Scour of the overspill is minimal because this design ensures floodwaters from both S1 and S2 merge without excessive turbulence.

The level at which S2 is set is critical; it is 300mm lower than the floor of the mill further down river, to ensure floodwater is diverted away from the mill. In practice, S2 replaced an unsightly concrete cascade weir built at the mill to protect it from flooding. The cascade has been boarded off and will be infilled once the performance of S2 is proven to be satisfactory.

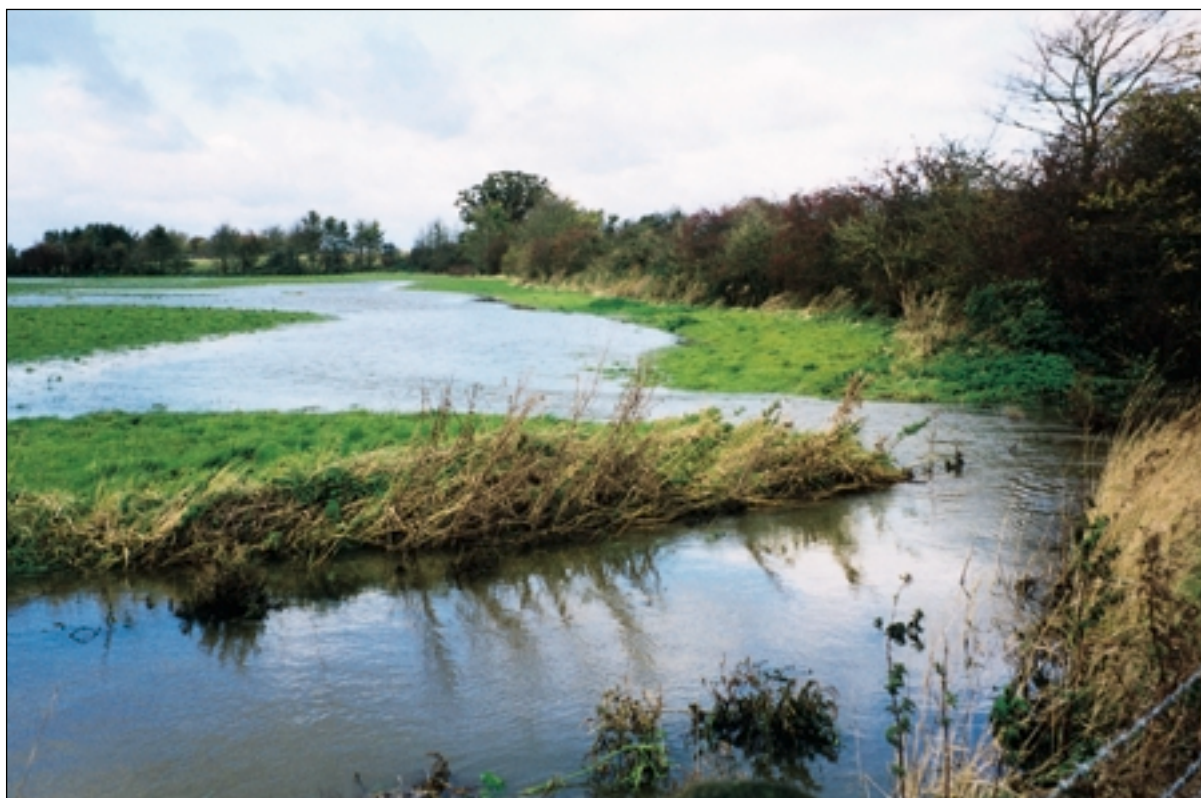
Spillway **S4**. Floodwaters spilling into field gully.

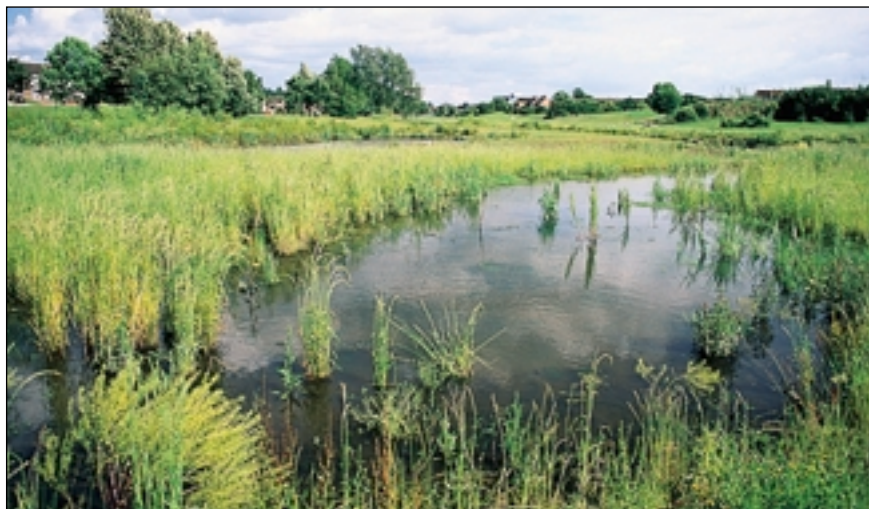
Completed spring-fed scrape

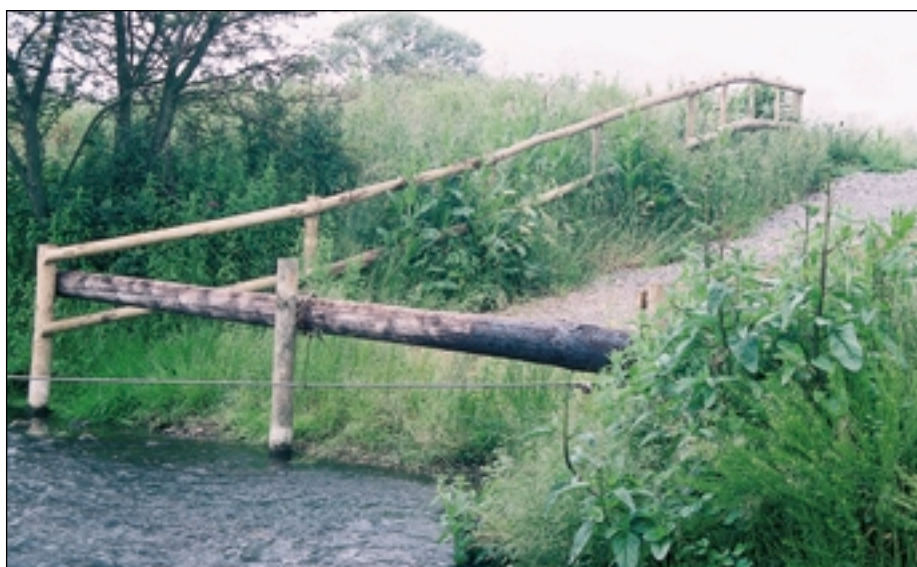
Stock watering point
at ch. 100m

Located at ch. 100m just downstream of a sharp bend in the new river course where a fast flowing riffle of gravel was expected to form. This hydraulic condition, combined with the careful contouring of the adjacent river banks, helps to avoid the risk of siltation that all too often renders watering points useless. The post and rail fencing around the ramp is tied into bank top fencing on either side, as well as across the river, to form a secure field boundary point.

The river fencing comprises a single heavy wire cable strained tightly across on a diagonal line (see photograph). The extra length of the diagonal renders the cable less likely to form a complete blockage of the river if floating debris becomes snagged on it. The angle of the diagonal is aligned to direct turbulence caused by its presence towards the mouth of the watering point, further reducing the risk of siltation.

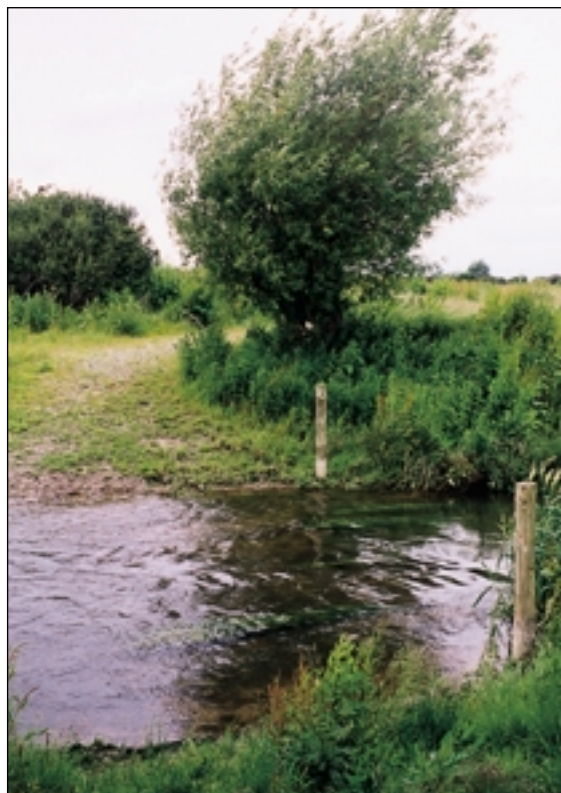
Equestrian ford at ch 620m

Despite the commonality of the design concept, each is individually configured to take advantage of local conditions and this is evident in the variety of visual interest and habitat diversity that has resulted. Of particular note, water crowfoot is thriving in the tailstone of the equestrian ford and ch. 620m.

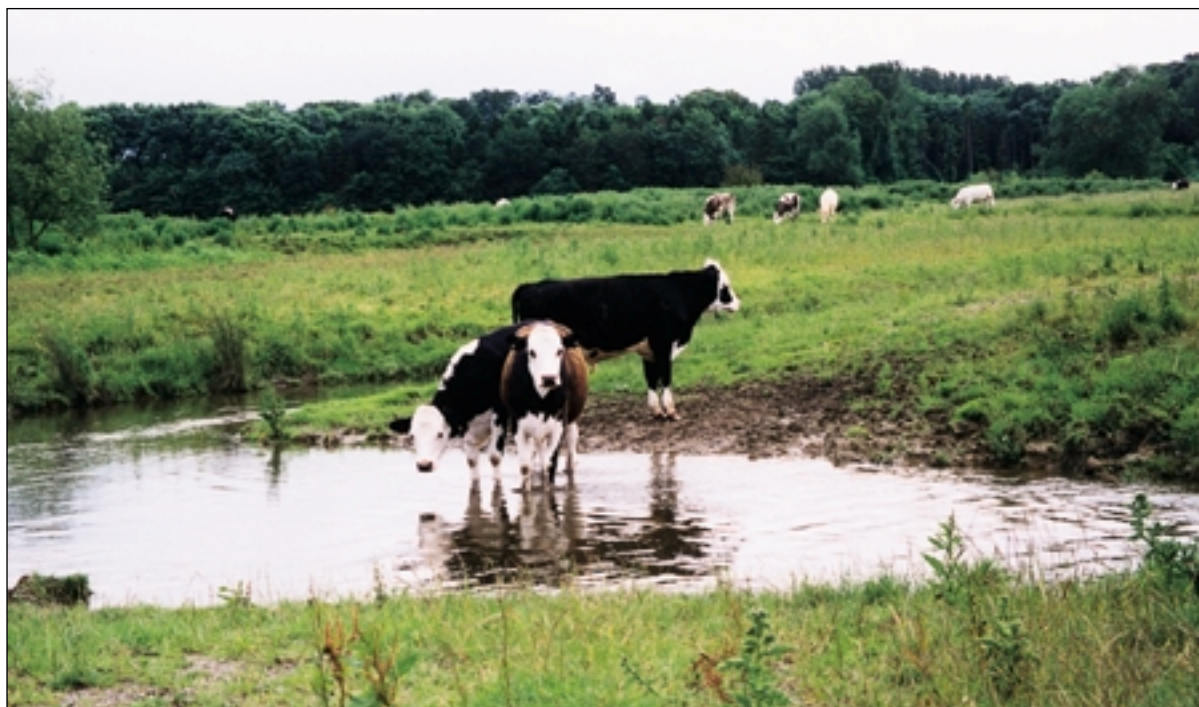
Vehicular ford upstream of mill at ch. 250m

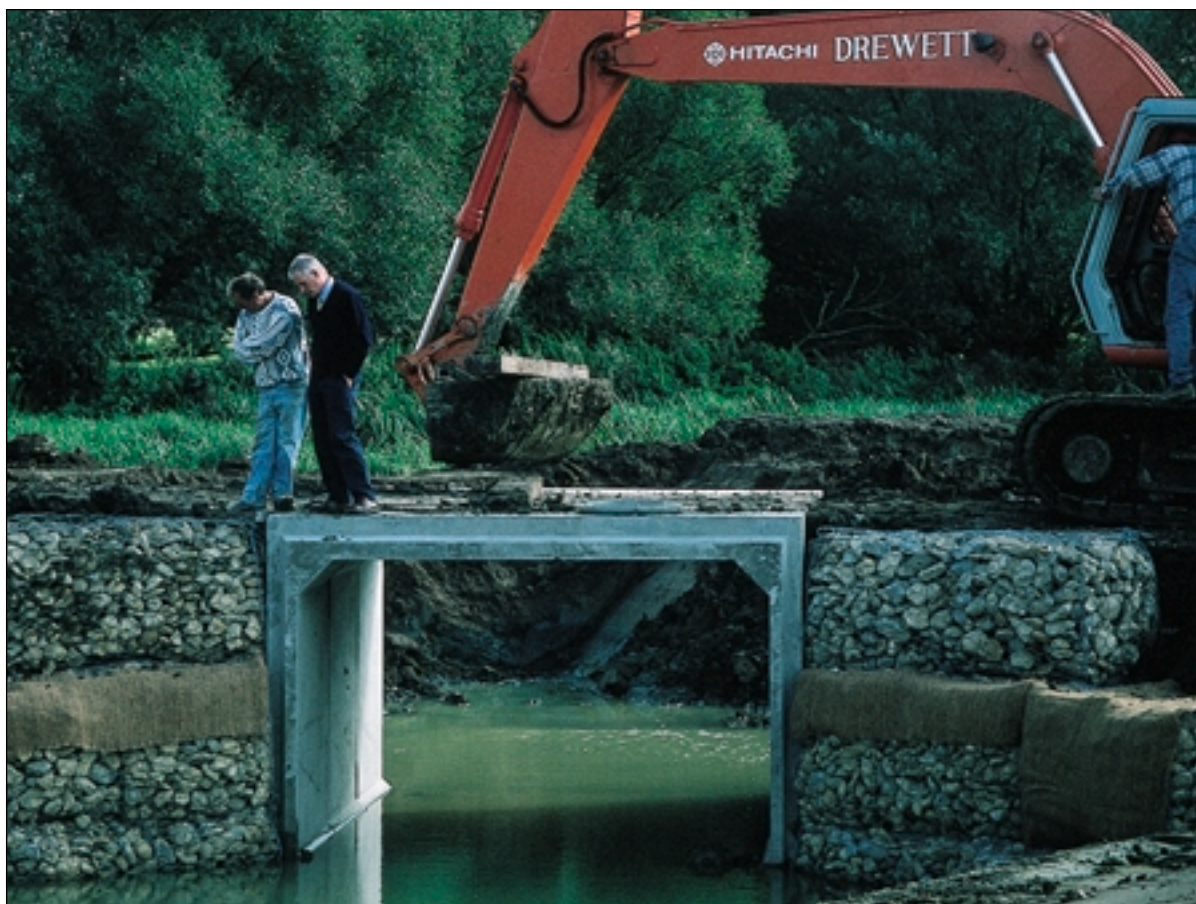
New concrete culvert crossing under construction

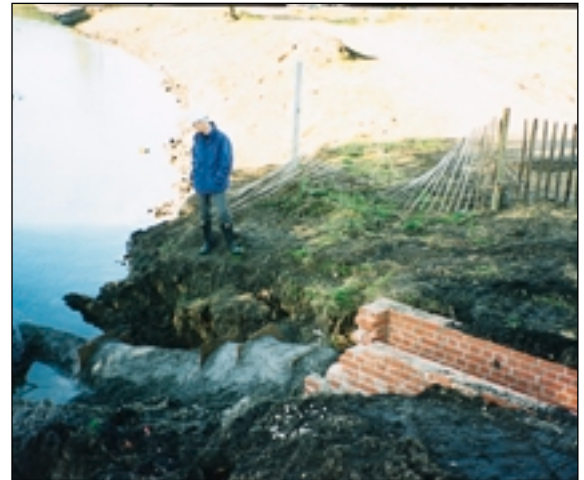
New outfall chamber under construction

NOTE: River bank reinstated with soil and toe planting such that no visual evidence of the outfall exists

Angled to discharge below low water level, the outfall pipe lies on a concrete apron which reduces scour during high flows. The outlet is turned to face downstream so that the river draws the discharge. Additionally, an underwater gabion was installed upstream of the outlet to reduce the risk of pipe damage by floating tree branches, etc. Direct jetting via the chamber is possible if outlets become silted but they are expected to be self cleansing. The velocity of discharge achievable has been seen to make the river 'boil' after heavy rain.

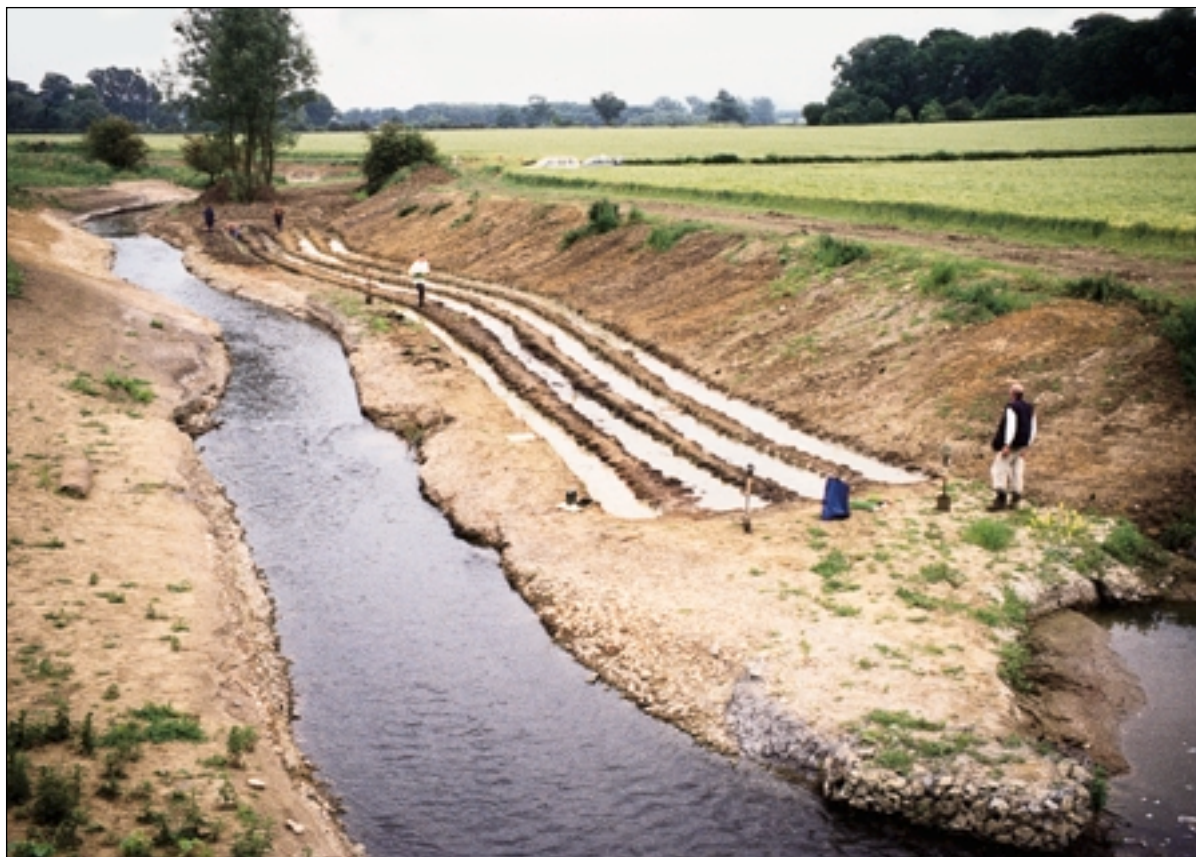
Planting reedbed – Spring 1996

Common reeds were introduced in spring 1996 using pot grown seedlings along one side of each furrow and seed along the opposite side (fig. 9.2.3). The use of two methods increased the likelihood of successful establishment and enabled the performance of each to be monitored.
